Fault diagnosis and analysis of analog module in a nuclear power plant

Suzhou Nuclear Power Research Institute Co.,Ltd
Shenzhen, China
E-mail: 1554789076@qq.com

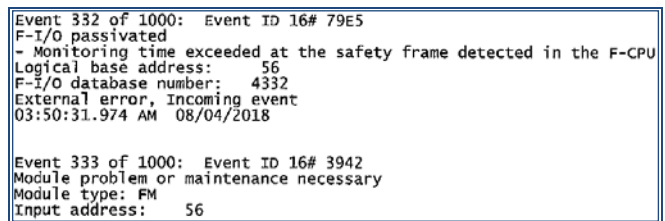
Fig2 Module fault diagnosis information

Call the fault diagnosis information of the Siemens module when the event occurs. The diagnosis information indicates that the module has communication fault, which leads to the module passivation, as shown in figure 2.

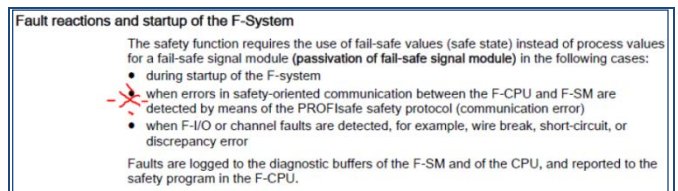
Fig.3 Fault response and startup of fail-safe system

Regarding to the EOMM manual of the module, there are three failure modes of module passivation^[2], as shown in figure 3.

According to the actual situation and the module fault diagnosis information, the module passivation is caused by communication failure, which is the second failure mode in the figure 3.

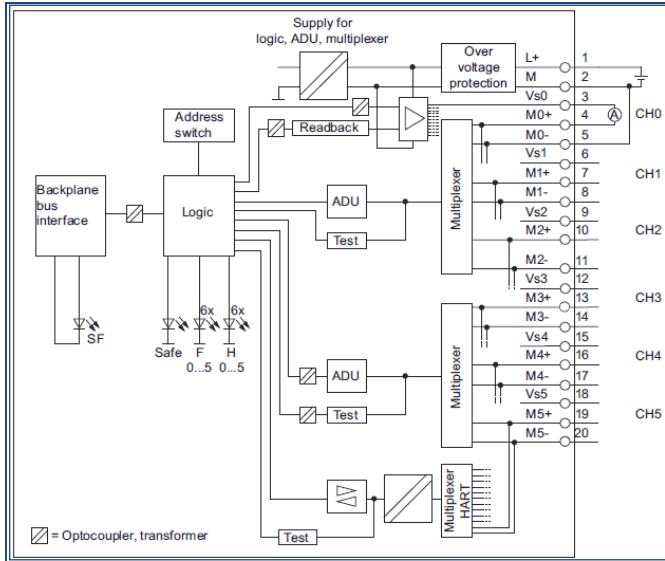
Fig.4 Schematic diagram of module circuit

The communication function of the module is shown in figure 4. The red wireframe includes CPU chip, chip software configuration, module backplane pin interface and address dial switch.

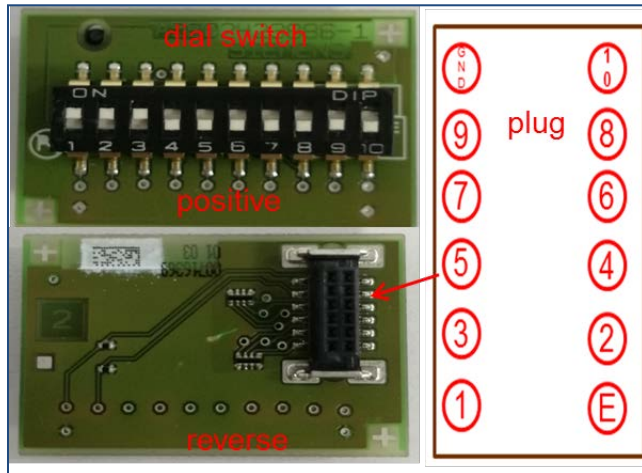
Fig.5 Address dial switch circuit board

The function of the address dial switch circuit board is set the address of on the rack, which is connected with the main circuit board of the module through the plug. The chip on the main circuit board can identify the module address by detecting the high and low level at the plug. As shown in figures 5.

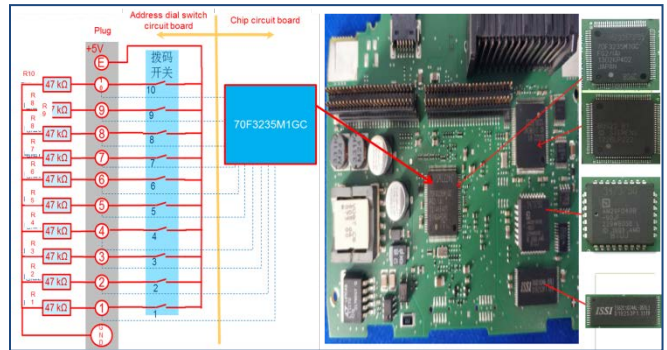
Fig.6 Schematic diagram of module address recognition

The processor of the module is 70F3235M1GC, which mainly provides communication and data operation functions,

and is widely used in the industry with stable performance. If the module CPU is abnormal, it will cause the module communication failure. However, the function of the module will return to normal through hot restarting, so the possibility of CPU hardware failure of this module is low.

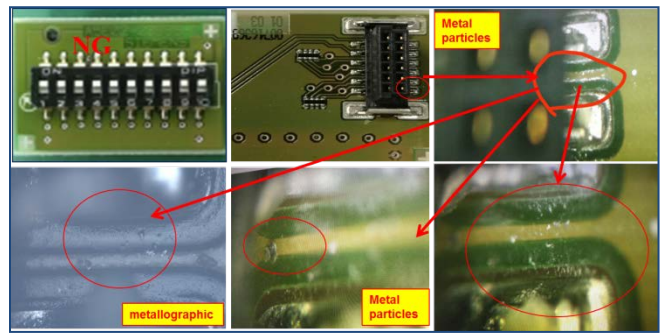
Fig.7 Morphology of address dial switch

The module address dial switch has a total of 10 bits of address. The position of the module is 56 in the cabinet, which is inserted into the PCBA through the plug. Observe the morphology of switch pin and solder under scanning electron microscope (SEM) and metallographic microscope^[3], as shown in figure 7.

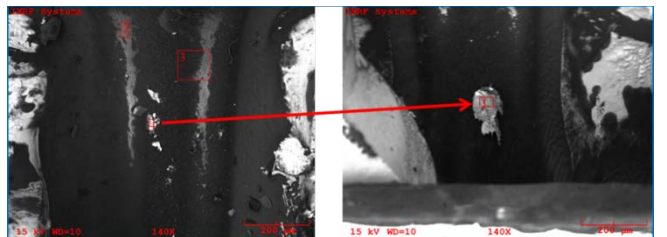
Fig. 8 SEM observation of pin of module address dial switch

The address dial switch PCBA was placed under the SEM. It was found that there were abnormal phenomena at E position and pin2 of power supply terminal, as shown in figures 8.

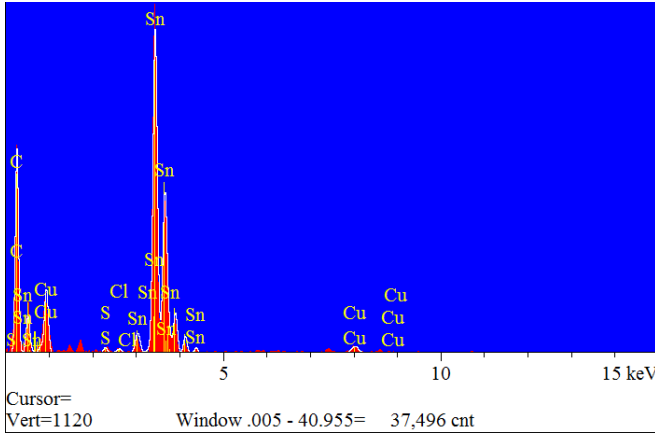
Fig.9 EDS analysis spectrum of module address dip switch pin

The results of energy spectrum analysis are shown in figures 9 and table 1.

The metal particles between the plug pins of the address dial switch circuit board are metal tin (Sn), which is the same as the material of the solder joint of the plug pin. It is the residual solder when the plug surface is mounted and welded.

Through the comparative analysis of the morphology observation and electrical performance measurement of the module, no abnormal phenomenon such as metal migration was found in the PCBA module^[4], but there was solder residue at the plug pin of the address dip switch of the module.

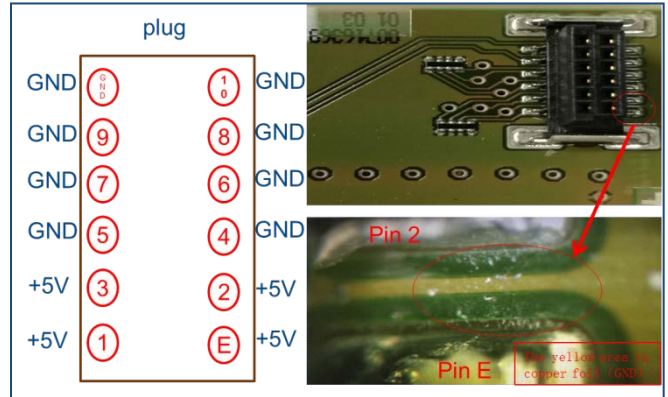
Fig.10 Potential distribution of plug pin

At present, SMT technology is widely used in PCB mounting, which has a high degree of automation. The E of the power supply of module, pin 2 and the GND position of copper foil in PCBA yellow area are all dispersed with solder. From the morphology analysis, it can be seen that the solder is residual when the plug is installed, as shown in figure 10.

The address of the fault card is 56, and the dial switches 1, 2 and 3 are all closed, so the plug power supply, 1, 2 and 3 are at high level, and the rest are grounded. There is copper foil ground between pin E and pin 2, and metal particles are distributed between pin E of plug, copper foil ground and pin 2, pin E and pin 2 are high level. During the normal operation of the module, dust or moisture will cause the insulation resistance between pin E or pin 2 and the copper foil ground to be reduced or even short circuited, resulting in the voltage reduction at pin 2, pin 3 and pin 1, the high level at pin 1, pin 2 and pin 3 will become low level, and the module address will change, resulting in communication failure.

According to the diagnosis information of module, and the failure mode of module passivation, it is determined that the module failure is caused by communication fault; there is copper foil ground wire between plug pin E and 2 of module address dip switch circuit board, and metal particles are distributed between plug pin E, copper foil ground and pin 2, pin E and pin 2 are high level. During the normal operation of the module, dust or moisture will cause the insulation

resistance to be reduced or even short circuited between pin E or pin 2 and the copper foil ground, resulting in the voltage reduction at pin 2, pin 3 and pin 1, the high level at pin 1, pin 2 and pin 3 will become low level, the module address will change, resulting in communication failure.

The solder residue in the plug pin of address dial switch circuit board is the most likely to cause module abnormality.

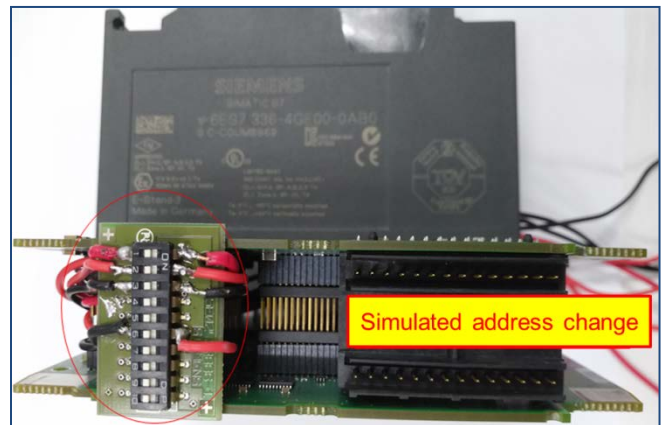
Fig.11 Analog module dial switch address change

As it is impossible to simulate the working condition of the change of the dial switch address, the welding method is adopted to draw out the dial switch pin, and the artificial disconnection or short connection is used to simulate the working condition changed of the dial switch address for the test, as shown in figure 11.

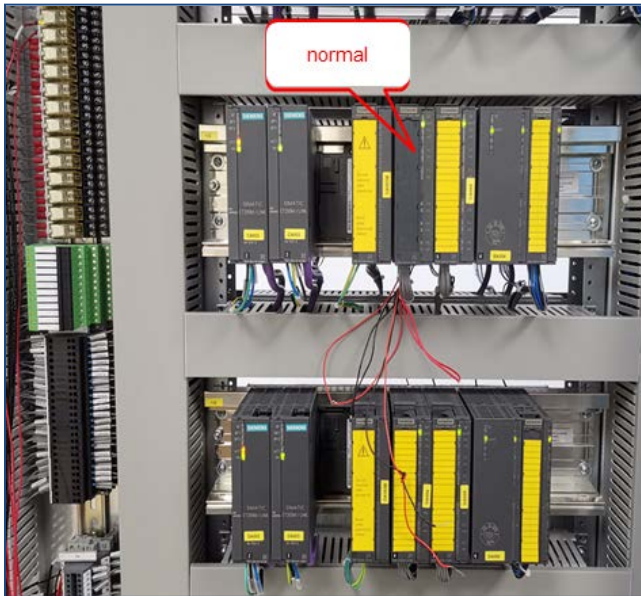
Fig.13 The experiment racks

Through many tests, when the module is installed in the cabinet according to the correct address, and the dial switch address is adjusted according to the above method, the module address is changed artificially for about 20 minutes, the whole module is passivated, the SF indicator light is always on, and the reset fails, as shown in figure 13.
