Fault diagnosis and analysis of analog module in a nuclear power plant

Suzhou Nuclear Power Research Institute Co.,Ltd
Shenzhen, China
E-mail: 1554789076@qq.com

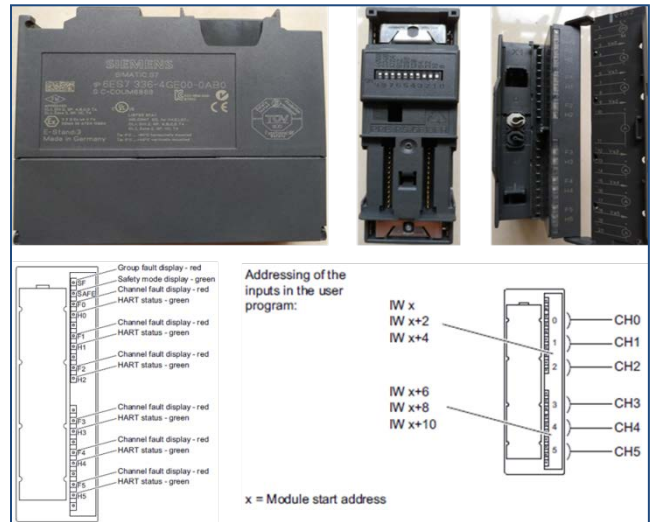
Fig.1 SM336;F-AI 6x0/4-20mA HART module

Fault module is used to receive analog input data transmission and processing in industrial field, as shown in the figure 1.
